Summary
Structural Evaluation
of
Surfside Beach Pier
Surfside Beach, SC

Chao and Associates, Inc.

August 2011

RE: Structural Evaluation of Surfside Beach Pier in Surfside Beach, SC
C&A Project No. 393703B

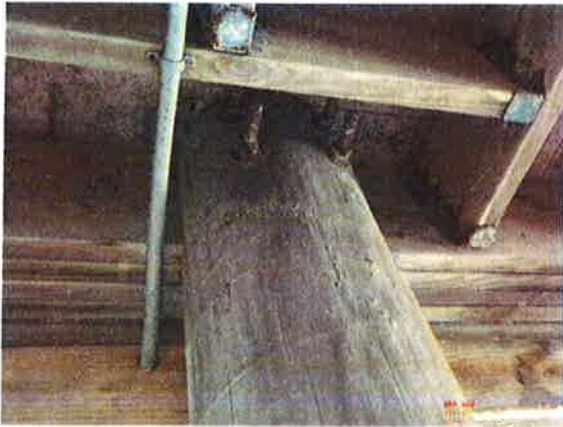
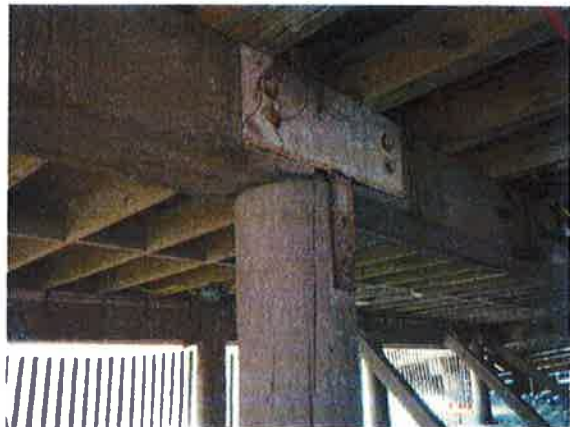
- 1 Most of the face mounted joist hangers, connecting through bolts and steel plates shows signs of heavy corrosion or noted to be missing (Photo 3, 4, Typ.).

Recommendation:

Replace all corroded or missing hangers, bolts and steel plates with Grade 316 stainless steel hardware. Sizes shall match existing.

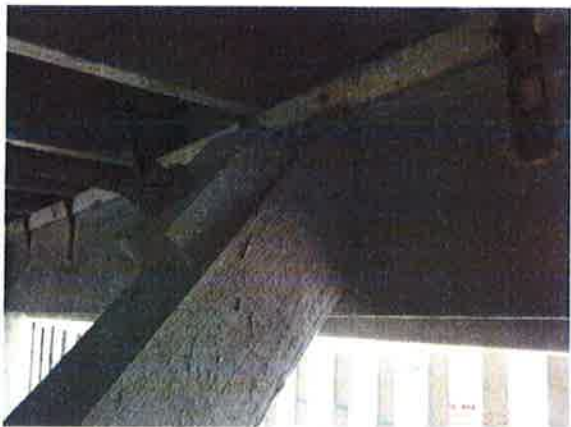
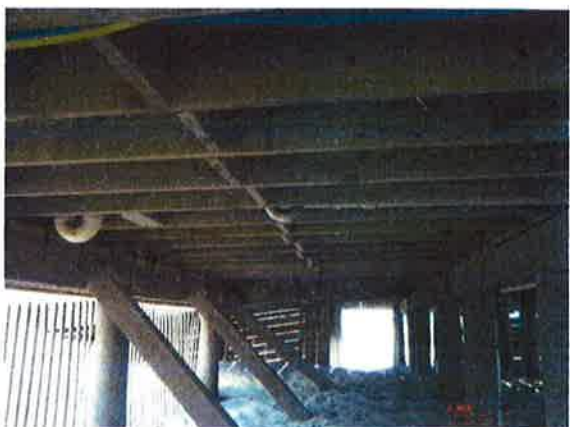
- 2 Most of hurricane ties and beam hold down hardware show signs of heavy corrosion or are noted to be missing (Photo 5, 6, Typ.).

Recommendation:

Replace all corroded or missing hurricane ties and provide hold down hardware at each beam end of Grade 316 stainless steel. Sizes shall match existing.

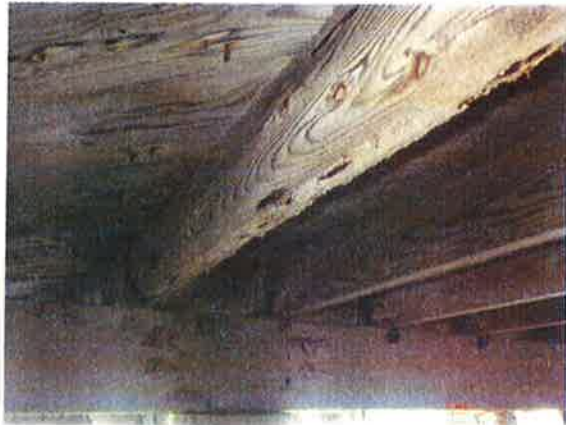
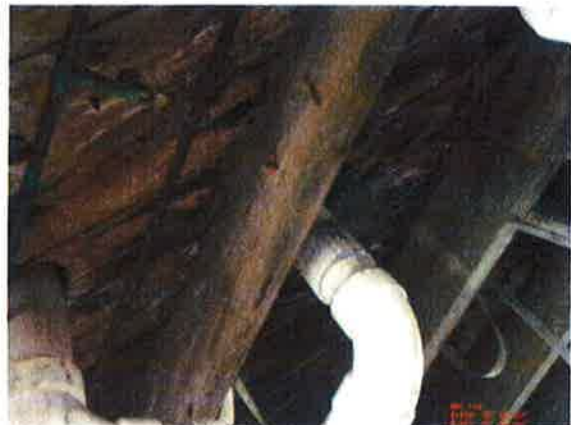
- 4 Some floor joists and floor deck planks were noted to show signs of rot and decay. (Photo 9, 10, Typ.).

Recommendation:

Scabbing an additional treated floor joist to the rotten joists, size to match existing. Remove the rotten floor decking and replace with treated floor decking, size to match existing.

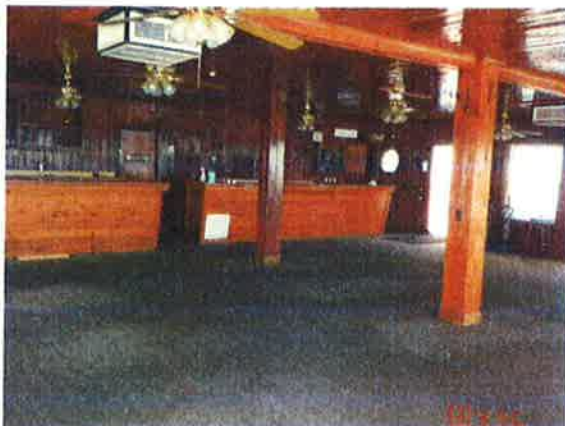
Photo 11

- 5 There were two interior columns inside of building A, believed to serve as roof load bearing elements. A lack of solid bearing/support was noted at the bearing of the columns, between the floor decking and the beam framing below. The column is measured to be approximately above the beam line. (Photo 11, 12, Typ.).

- 6 There was an interior wall inside of building A that possibly serves as a roof load bearing element. The wall was measured to bear on the floor joists. The floor joists are noted to be insufficient to support loads associated with a load bearing wall. (Photo 11, Typ.).

Providing treated solid blocking between the decking, directly below the column, and the beam below. Additionally, hold down connecting hardware shall be provided between the column and supporting beam, utilizing grade 316 stainless steel materials.

Further investigation is required to determine if the wall is a load bearing element and therefore the floor joist reinforcement requirements if it is determined to be so.

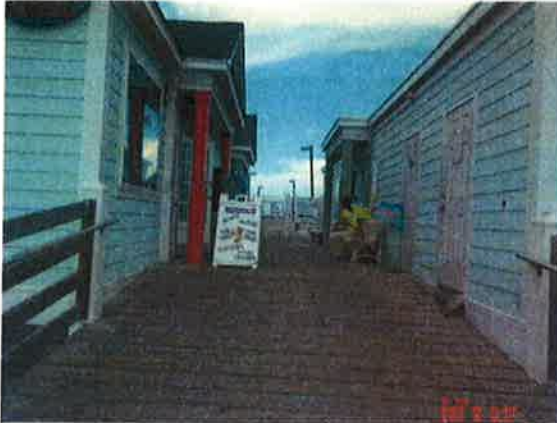
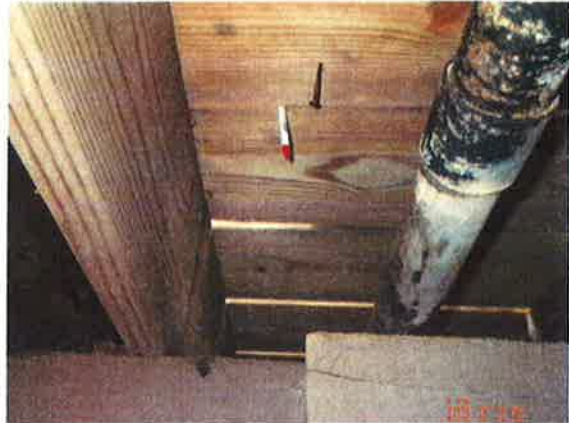
- 7 There were total of six exterior columns noted at the entrance for buildings A and B. It was noted that no direct solid bearing/support or hold down connection was present between bottom of decking and the supporting framing below the column bearing. (Photo 13, 14, Typ.).

Recommendation:

Providing treated solid blocking between the decking, directly below the column, and the beam below. Additionally, hold down connecting hardware shall be provided between the column and supporting beam, utilizing grade 316 stainless steel materials.

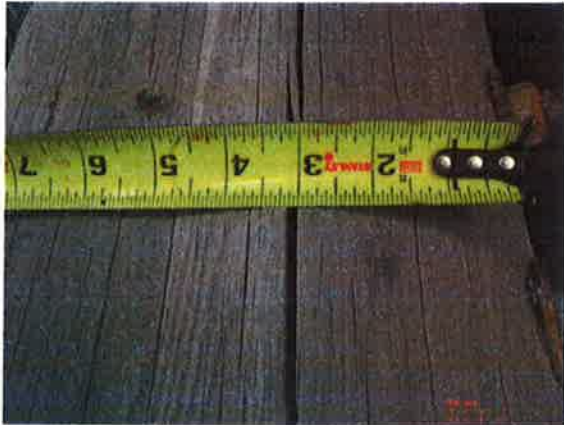
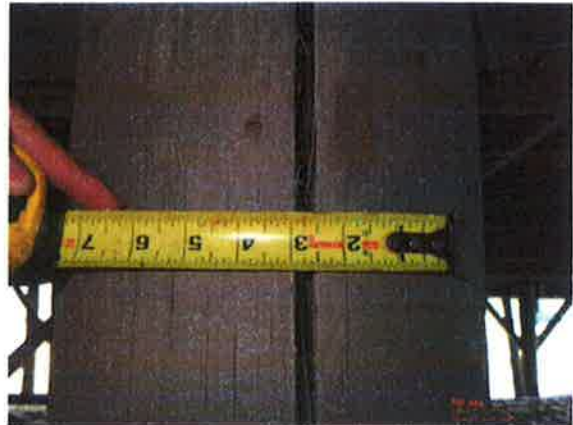
- 8 Wood pile checking was noted at most of piles. The maximum checking width is measured to be approximately 1/2". (Photo 15, 16, Typ.).

Recommendation:

Currently there is no structural concern regarding the checking observed. It may become an issue of decreasing pile capacity when the checking lead into splitting. Annual pile inspection is recommended.

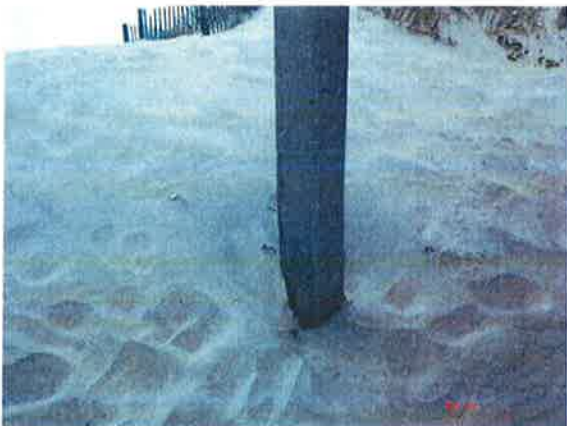
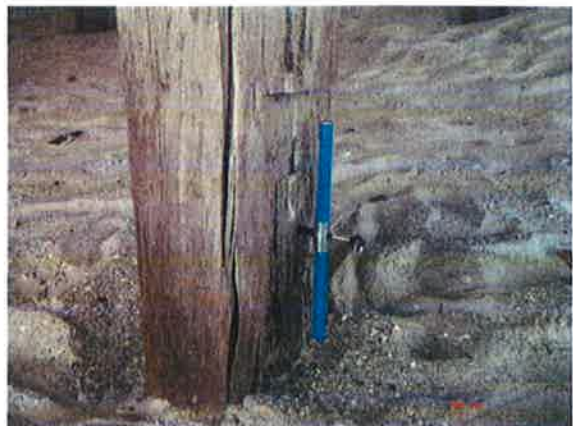
- 9 Some piles were noted to have "Reduced section" or splitting conditions at the building A side. Wood coring were performed at these piles to examine the structural integrity of the piles. (Photo 17, 18, Typ.).

The wood coring results appear to indicate no hollow section in the wood pile (Photo 19). However, the bearing adequacy of these piles will need to be re-evaluated when the new applied loading is determined and analyzed in conjunction with pile load testing results.

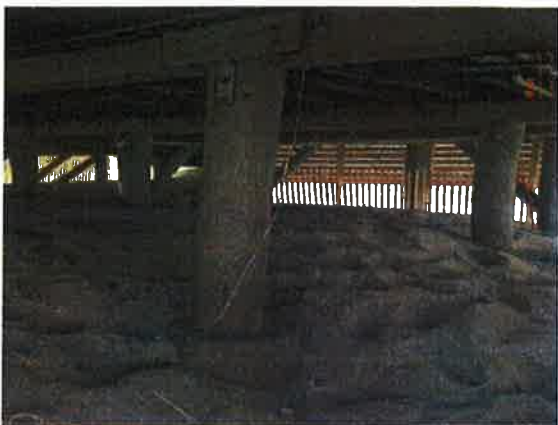
Photo 20

- 10 Two concrete foundation piers were noted at building B side. These concrete piers may likely be the reinforcing repair for the existing wood piles. This indicates that

existing piles may have had a structural deficiency or an inadequate bearing. (Photo 20, Typ.).

Structural bearing capacity of these piles will need to be evaluated when the new applied loading is determined and analyzed in conjunction with pile load testing results.

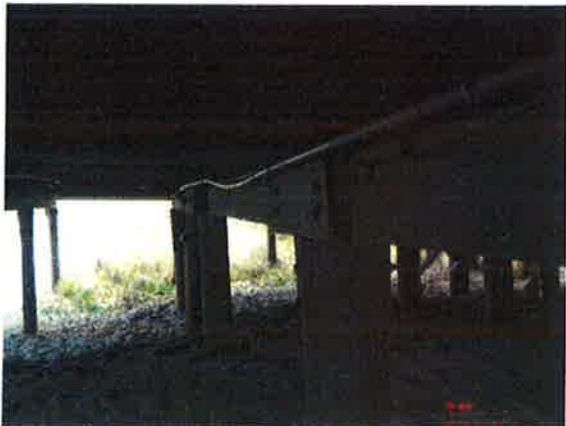
Photo 21

- 11 There were signs of likely settlement noted at a couple of pile locations. (Photo 21, Typ.).

Recommendation:

The structural bearing capacity of these piles will need to be load tested and evaluated to determine the adequacy of pile bearing.
